NASA CR-2166

FAILURE ANALYSIS OF  
ALUMINUM ALLOY COMPONENTS

*by Om Johari, Irene Corvin, and Joseph Staschke*

*Prepared by*  
IIT RESEARCH INSTITUTE  
Chicago, Ill. 60616  
*for Langley Research Center*

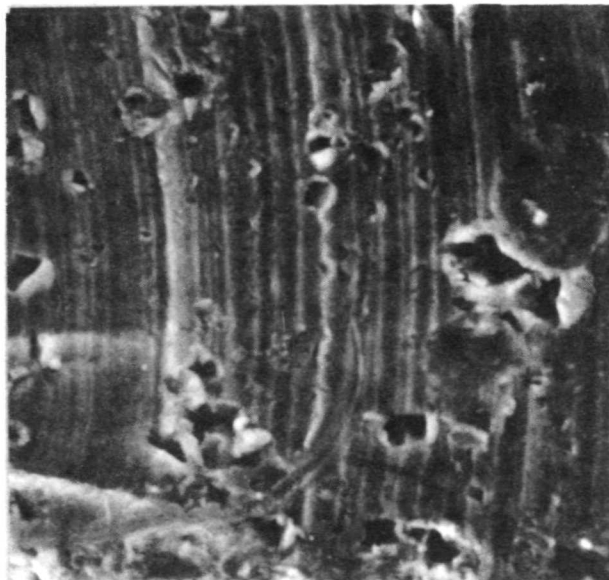
Fig. 9

Fatigue Striations in Another Region.

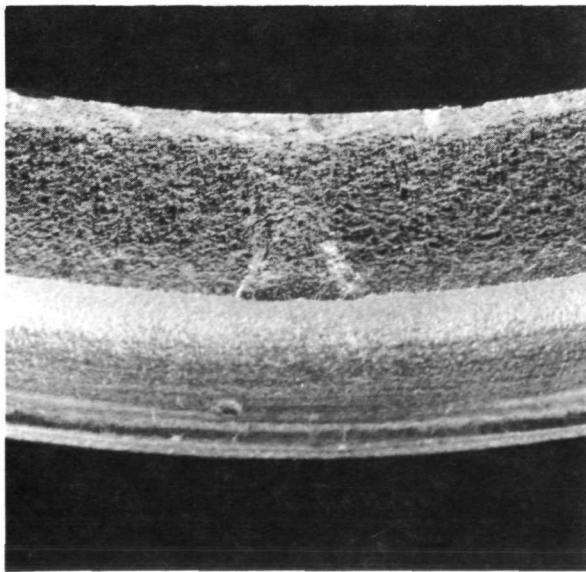
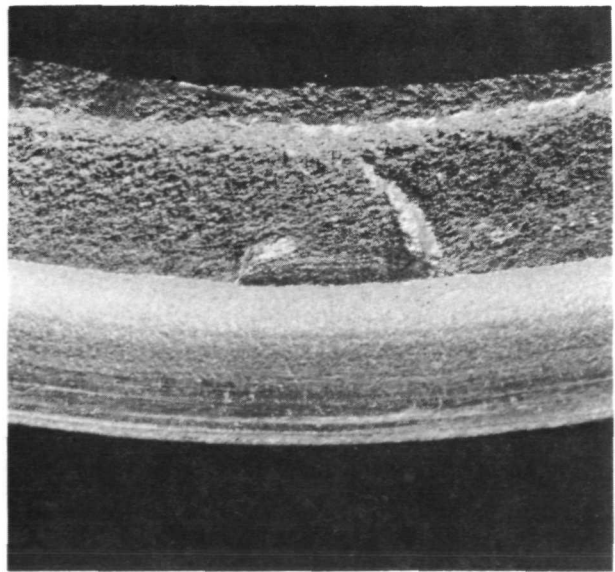
Figure 3  
Failed Part in the As-Received Condition  
by IITRI Indicating Areas Examined.

Figure 4  
Close-Up of Area 1 in Figure 3. Figure 5  
Close-Up of Area 3 in Figure 3.

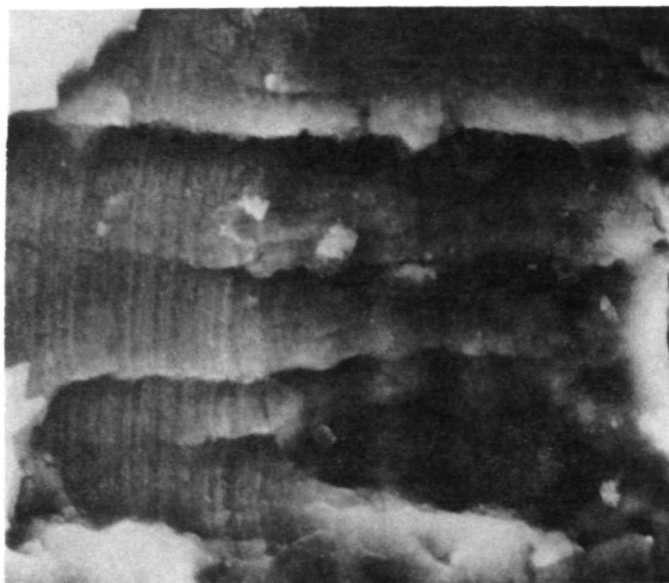
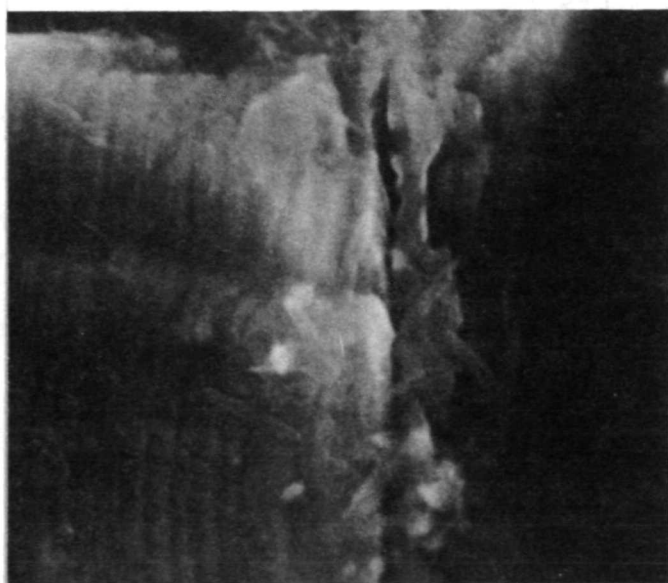
Figure 10

Figure 6 presents a composite photograph of area 3. Figure 7 is a higher magnification view of the center of the region SS of Fig. 6. Four distinct regions are identified, and in this report they are termed A, B, C, and D--A being closest to the outside shot-peened surface, D being the final fracture overload region. Typical features of region D are illustrated in Fig. 8a and 8b. Regions B and C were clearly separated because, both in high-magnification optical macrofractographs (Fig. 9) and in SEM photographs, region B was much darker than region C. Typical fatigue striations could be readily observed in region C. The direction of striations pointed towards the center of the area SS as the origin, though local effects of grain orientations were also observed (Fig. 10 a, b, c). Except towards the edges of the crescent SS (as shown in Fig. 10), the striations, for the most part, were parallel to the circumference of the ring-shaped sample.

Fatigue Striations in Region C. (a) Low magnification; while most striations point to the center of SS as origin, local differences in striation direction, attributed to individual grain orientation, are also seen. (b) Higher magnification of the top central region in (a). (c) Another region showing striations in region C. The SEM was operated at 25 kv for this photograph and at 5 kv for the photographs in (a, b); this accounts for the different appearance.

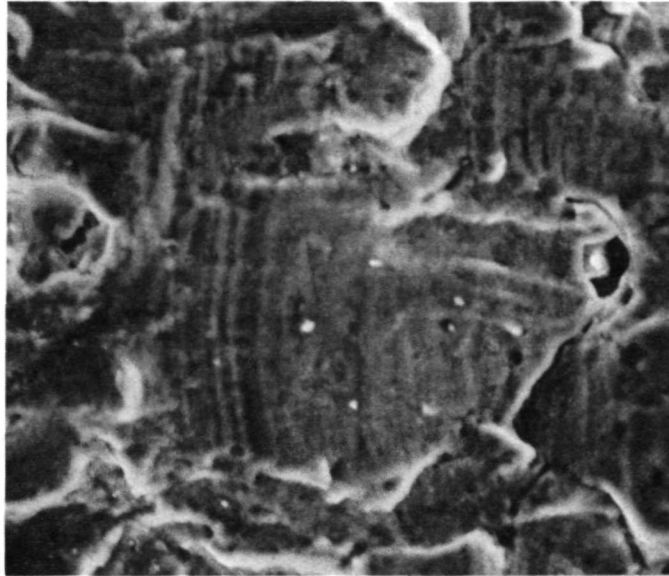
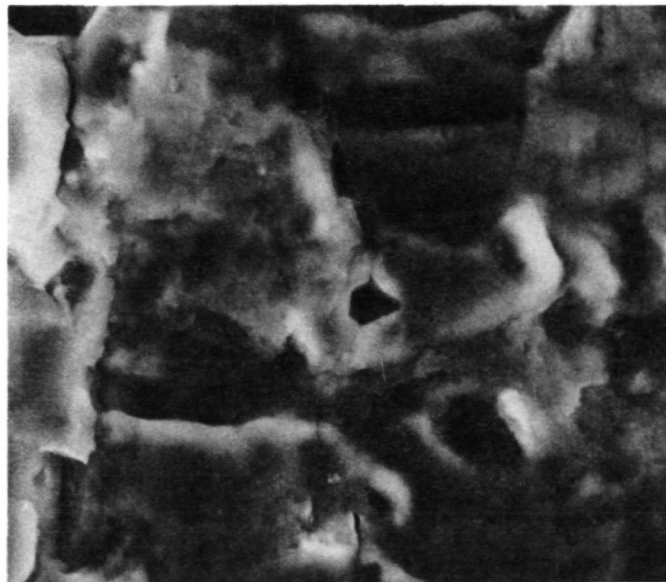
Figure 16

In the area outside the suspect-origin region described above (i.e., outside the region SS of Fig. 6) four similar regions were observed (Fig. 16 a, b). The features of regions C and D were identical. In all areas of regions B and C the striations were parallel to the circumference of the sample (Figs. 17 and 18). The darker region B (Fig. 17 a, b) was again more contaminated than region C, and though fatigue features are suspected, they could not be clearly resolved. In Fig. 18 a, b, and c the boundary between B and C is, again, very distinct. Area A (Fig. 19 a, b) is also very similar in the regions inside and outside SS of Fig. 6.

Region A in the areas observed (e.g., Figs. 7 and 16) extends to approximately 0.025 cm below the shot-peened surface. Since shot peening is employed to prevent fatigue failures by providing compressive stresses at the immediate surface (usually the first 0.013 cm or less), observations such as in Fig. 20 indicate that many areas were either not hit or very lightly hit by the shots and derived no benefit from the shot-peening operations. Large isolated areas of unfavorable stress states caused by poorly controlled shot peening and located at or near the minimum section of the strut could thus act as initiation sites. The observations of many suspect initiation sites support this explanation, although precise correlation between any surface defects and fatigue initiation sites was not found.

Two Areas Outside the Crescent-Shaped Suspect Origin Region SS. Four regions (A, B, C, and D), identical to Figure 7, are observed.

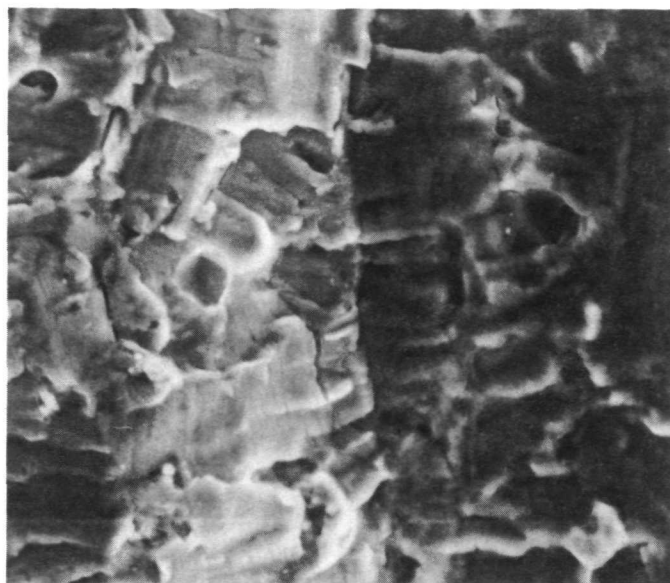
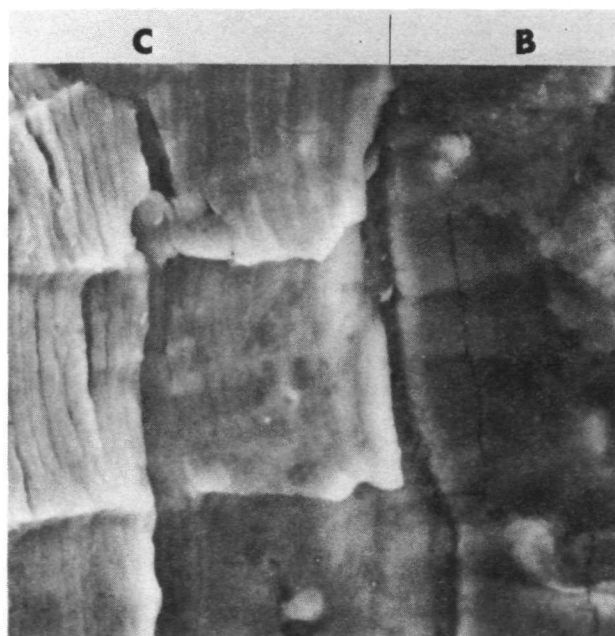
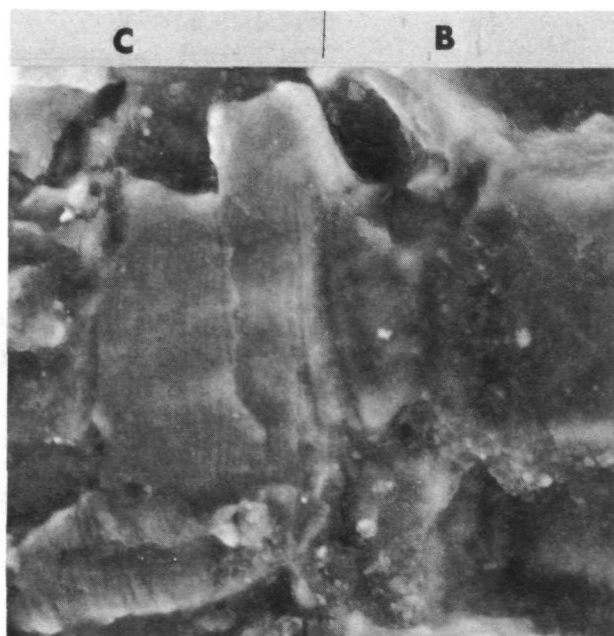
Figure 17

Two Views of Region B. (a) Presence of fatigue striations is not as clear as in left sides of Figure 18; in (b) fatigue features are not resolved due to surface contaminants.

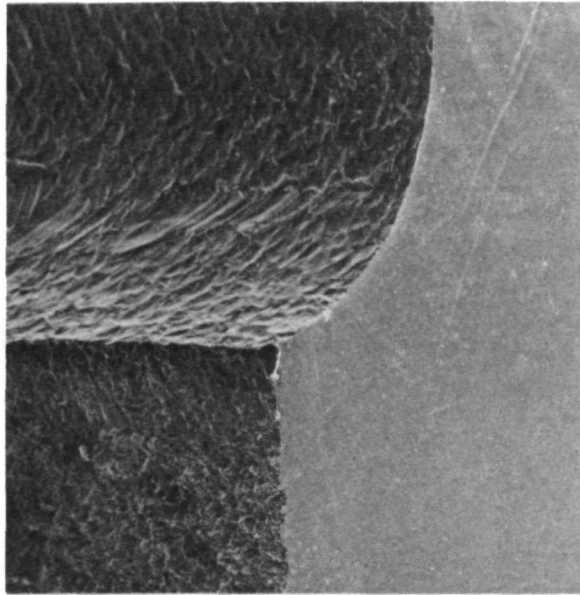
Figure 21

To further verify the shot peening damage a metallographic section was prepared (Figs. 21 and 22). Detailed SEM examination of this section (Fig. 23) revealed presence of many flaws and confirmed the uneven nature of shot-peening load distributions.

Relative Location of Shot-Peened Surface (top left), Fracture Surface (bottom left), and Metallographically Polished Section (right).

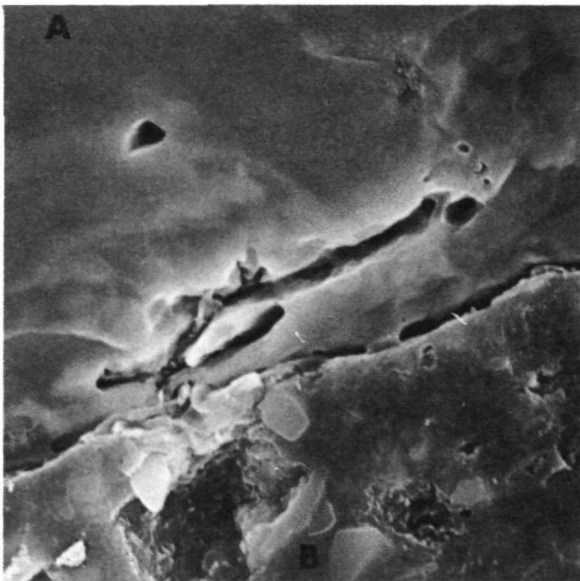
Four Views Showing Details of Shot-Peened Edge in Figure 22. Notice the extent of deformation induced and the nature of defects which are present. (All micrographs are secondary electron images in the SEM.) A is the alloy; B is bakelite.

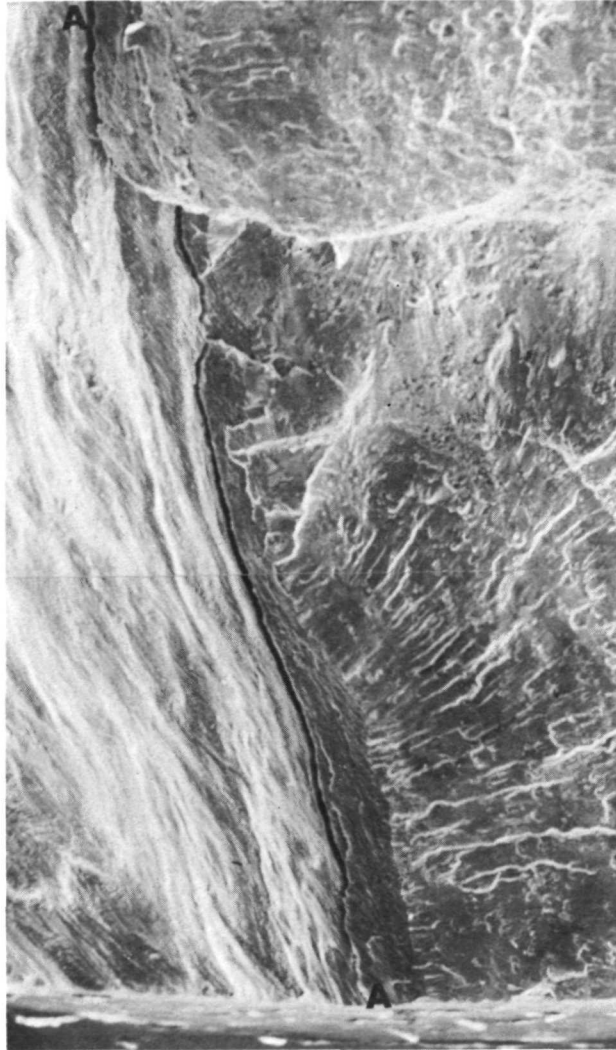
Figure 1

Overview of the Fracture Surface of Failed Wing Spar Forging in the As-Received Condition (Optical Photomicrograph)

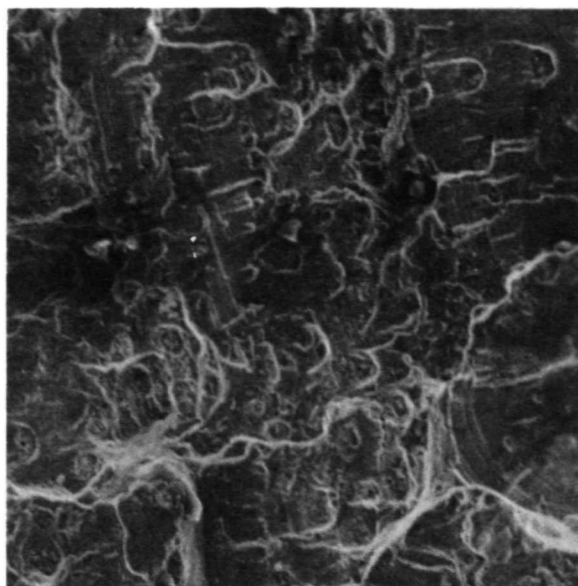
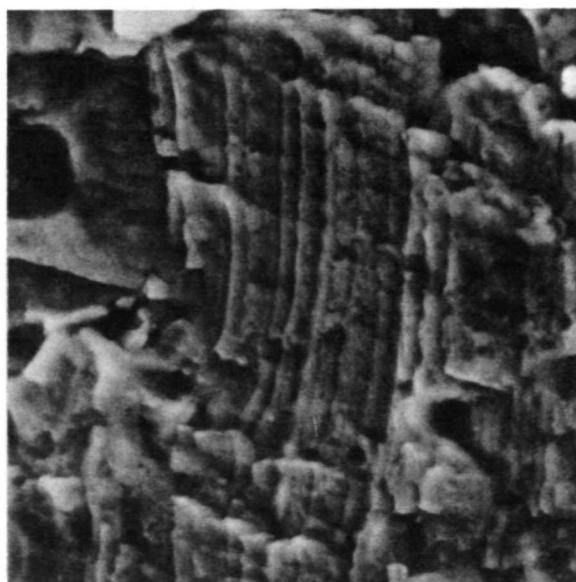
Figure 2

SEM Photograph of Area 0 in Figure 1.  
The area right of boundary AA contains  
many fatigue striations; the area left  
of boundary is the flaw surface.

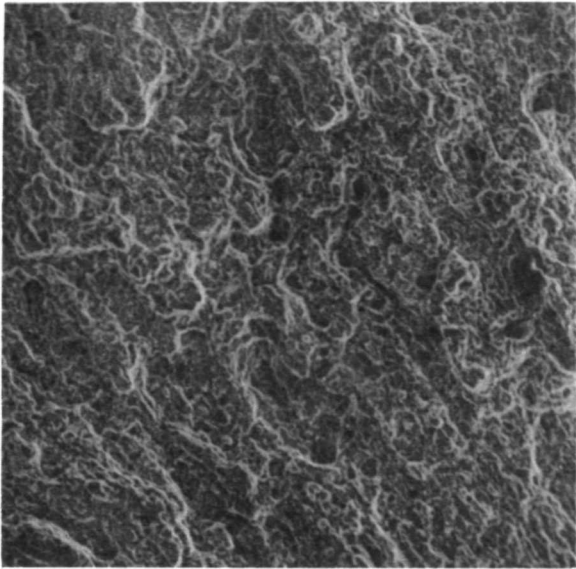
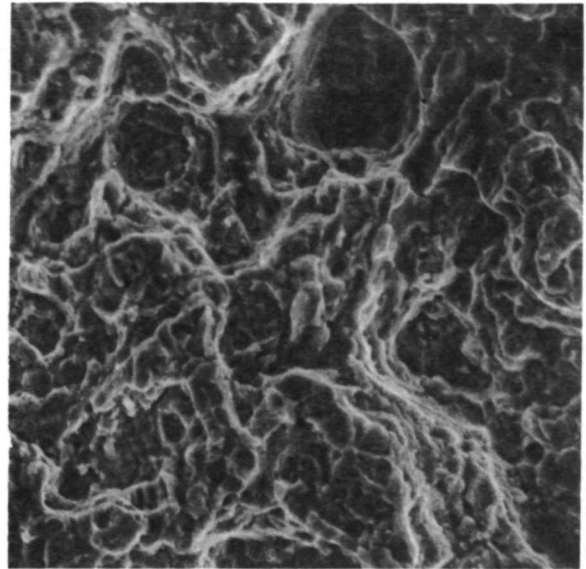
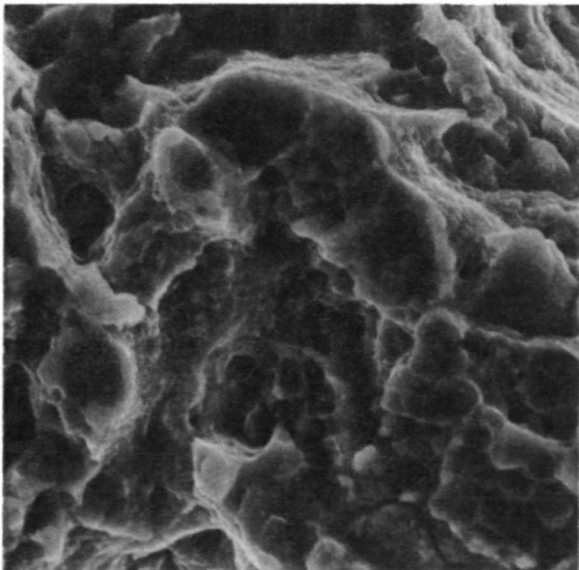
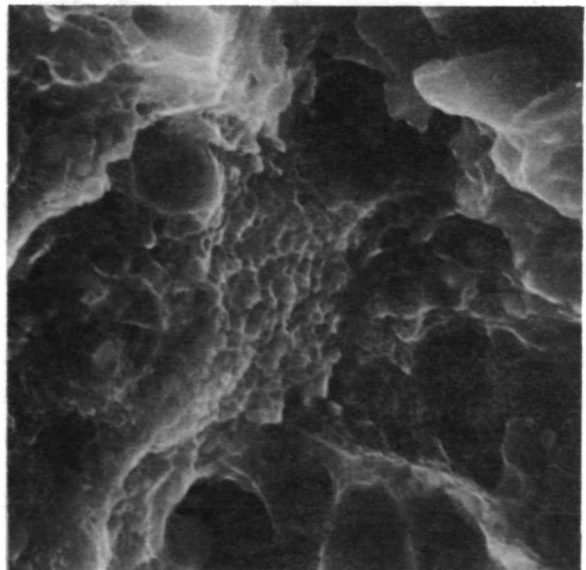
Figure 3

Fatigue Features--Striations and, in Some Regions, Striations with Dimples. Striations were parallel to the flaw surface.

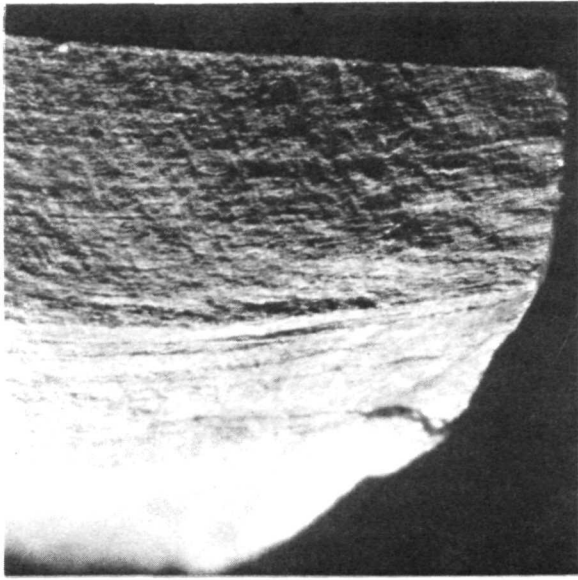
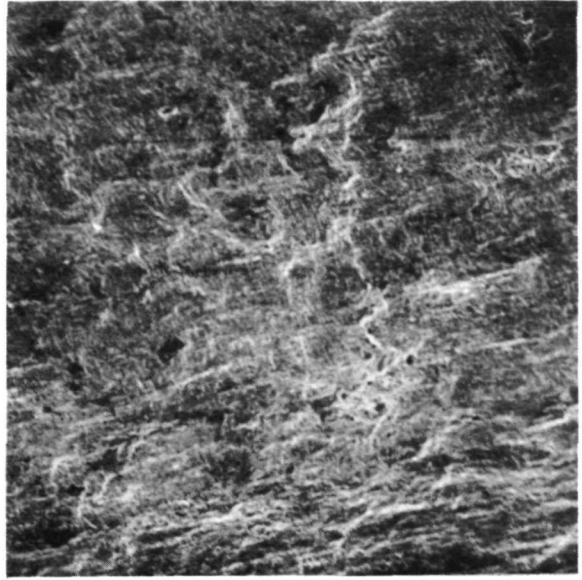
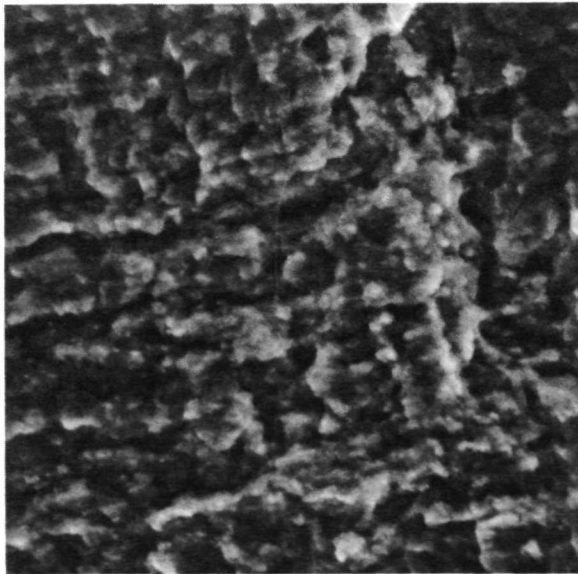
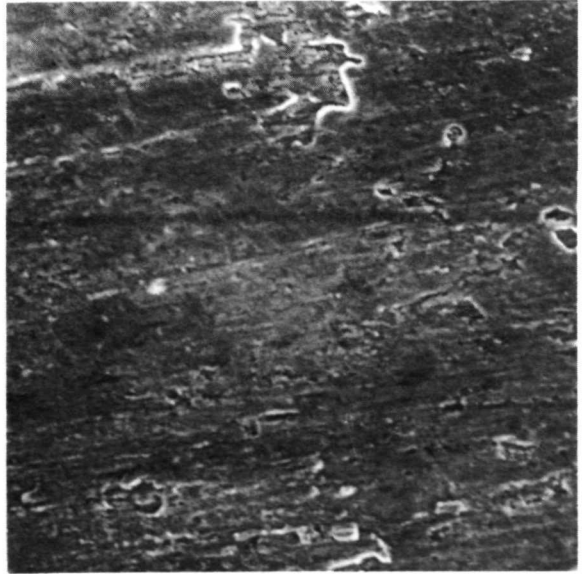
Figure 5

This fact was confirmed during the metallographic examination of a section parallel to the fracture face (Fig. 5). Figure 5a shows the surface near the flaw and machined edge CC of Fig. 1; while the grain flow pattern is good, the machining of the forged surface has rendered the structure weak in the direction perpendicular to the flaw, where fatigue features were observed. Many holes were present on this surface which was prepared by polishing, etching, cleaning with replicas, and coating with gold to prevent charging of bakelite mounting material. Some of these holes lined up along grain boundaries (Fig. 5b), and in some locations inclusions remained intact (Fig. 5c). The chemical analysis of one of these inclusions indicated them to be rich in copper, iron, and aluminum (Fig. 5d); other peaks in Fig. 5d are due to gold from specimen coating.

The origin of the flaw was considered from many aspects: a flaw resulting from a pipe in the casting and remaining throughout the forging operation; a flaw formed during the forging operation due to improper alignment of dies; or a flaw formed by diffusion of elements during the life of the part. The flaw surface BB (Fig. 1) was opened and examined in detail for any possible clues. No inclusions were found on the surface which appeared oxidized and covered by a surface film (see Fig. 6). The presence of many inclusions in the area close to the flaw (as indicated in Fig. 5)

SEM Metallographic Study--(a) overall view, A is the flaw surface; B the machined top surface; (b) details of some holes along grain boundaries indicating segregation; (c) some areas showed inclusions whose analysis in (d) indicated them to be iron and copper rich.

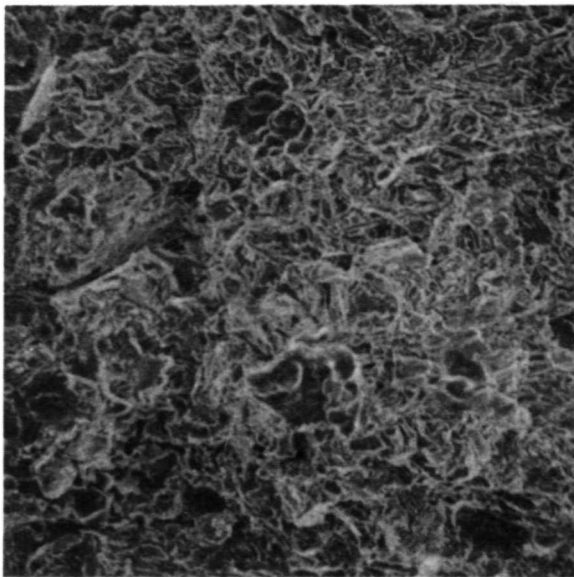
Figure 1

Optical Photomicrograph of Fracture  
in Bell Crank Fitting of Horizontal  
Elevator in As-Received Condition.

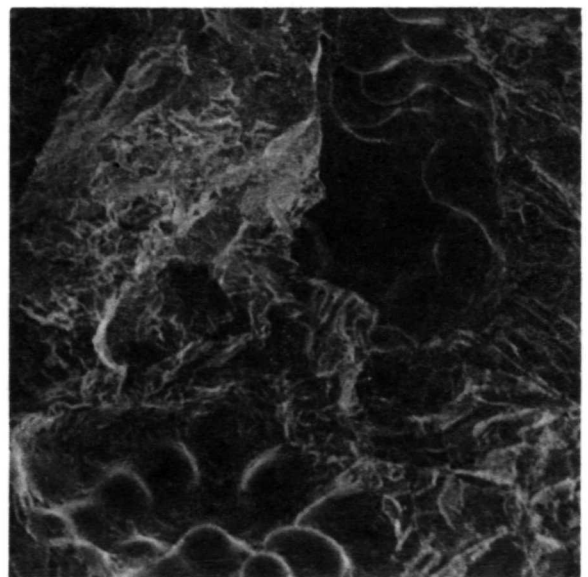
Figure 2

A Typical Area at Low Magnifi-  
cation.

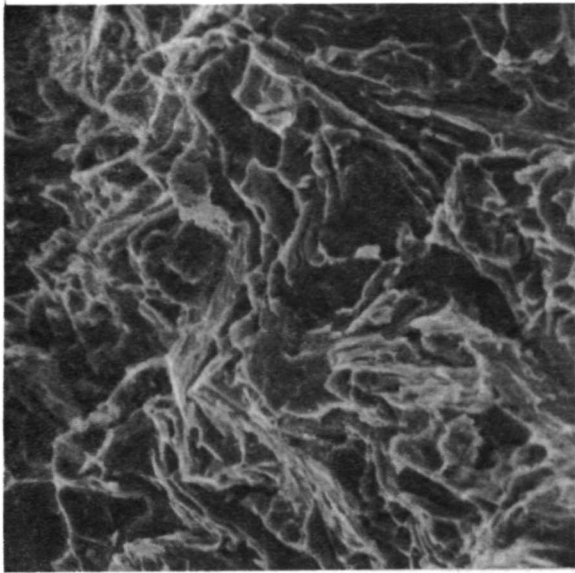
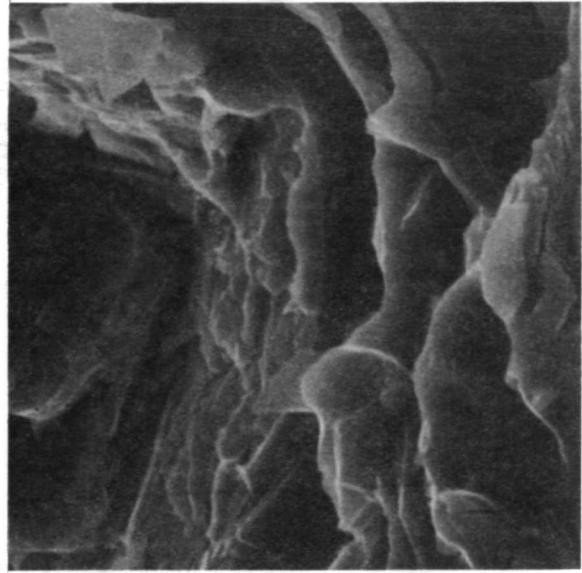
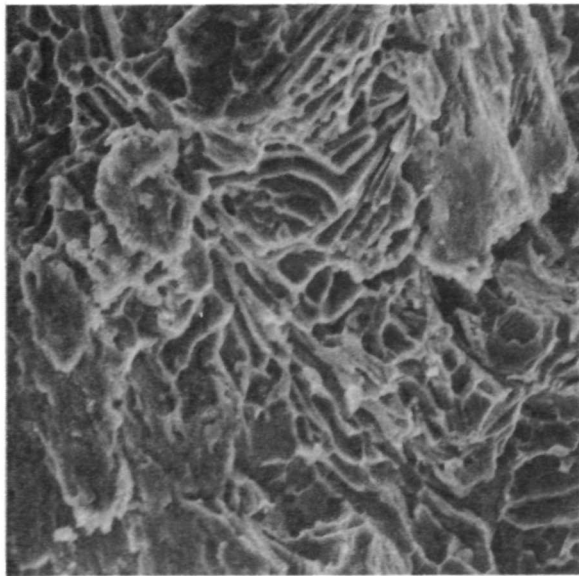
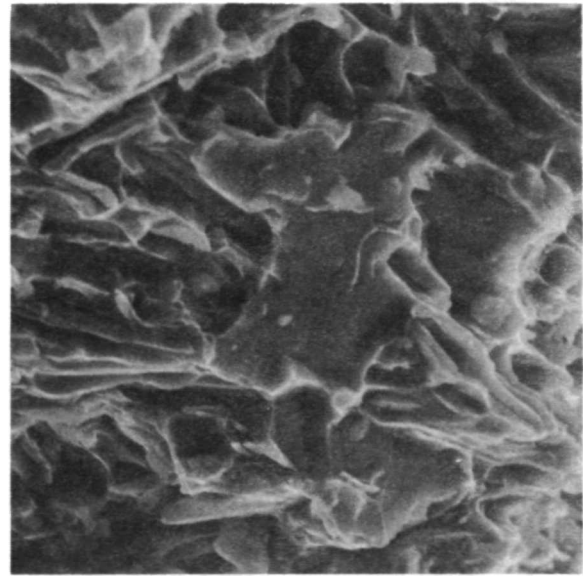
Figure 3

Fracture Surface Features That  
Are Associated with Porous  
Regions.

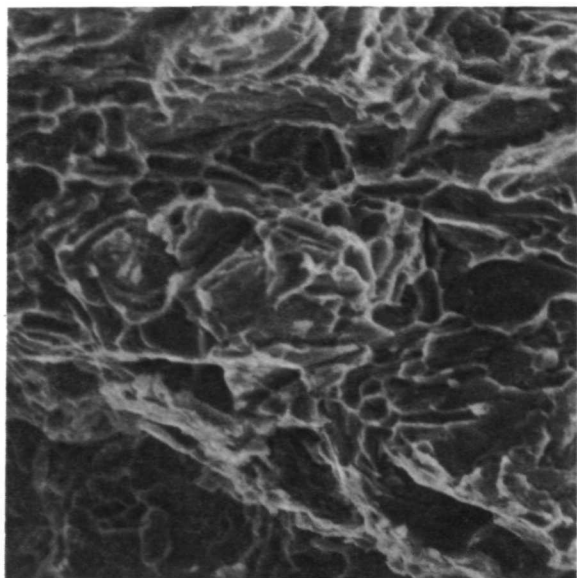
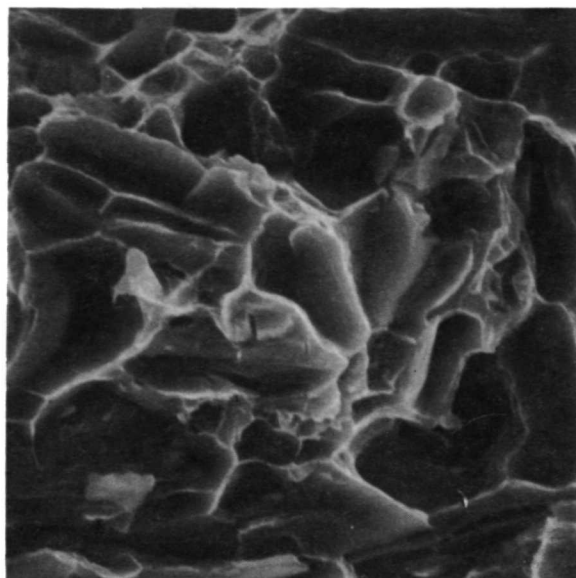
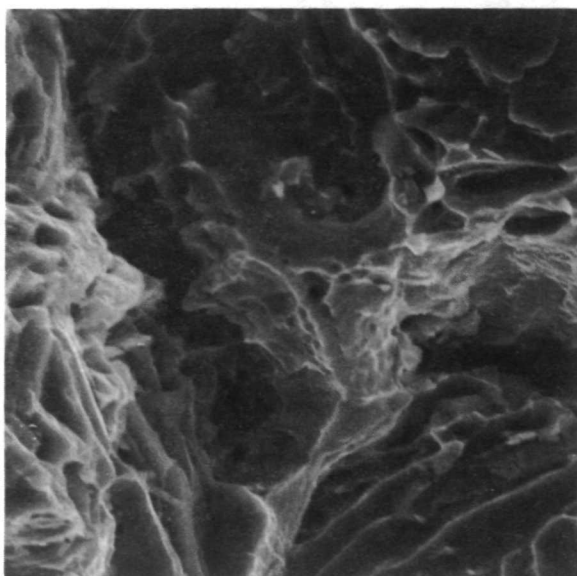
Figure 4

Typical Fracture Features. (a) and (b) are for the same area;  
(c) and (d) are for two other areas.

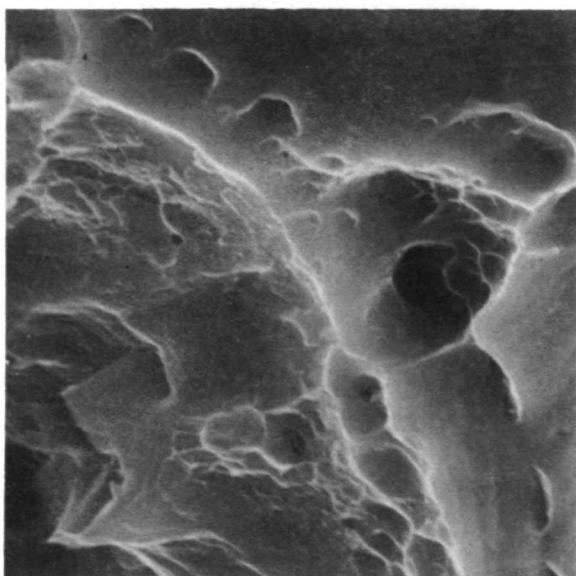
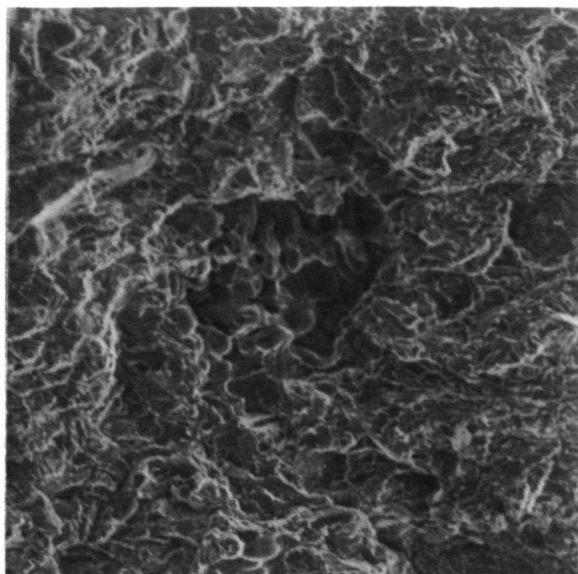
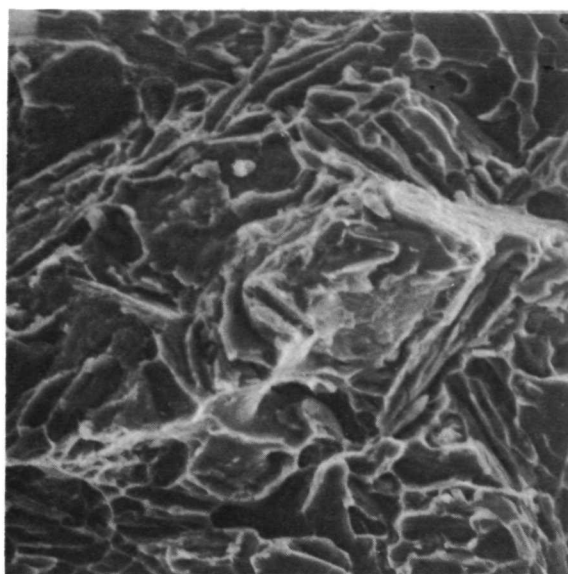
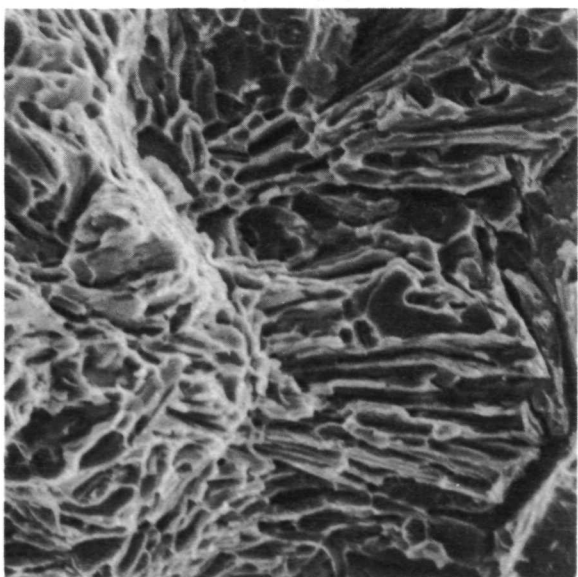
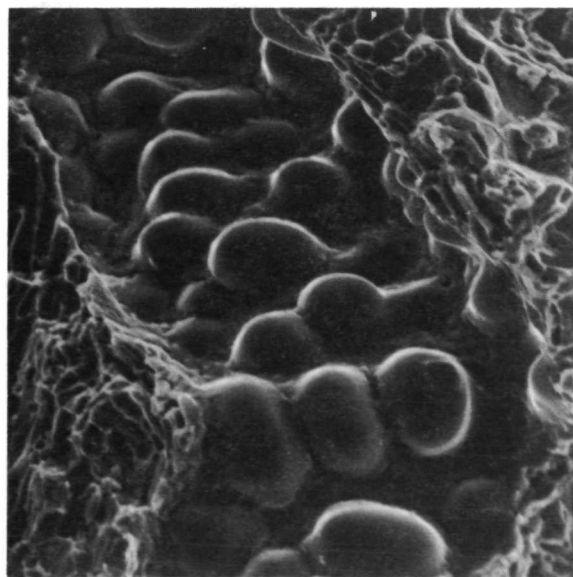
Figure 5 presents some of the general features of the miniature tensile specimen, and Fig. 6 shows the miniature impact sample. The presence of dimples in many areas of the sample in Fig. 5 and their absence on the fracture face of the failure clearly rule out that the failure was due to overload. The similarity between the miniature impact sample and the failure sample is striking, and the obvious conclusion is that failure in this part was caused by impact.

Four Views of Fracture Features in the Miniature Tensile Sample  
Made from a Piece of the Specimen in Figure 1.

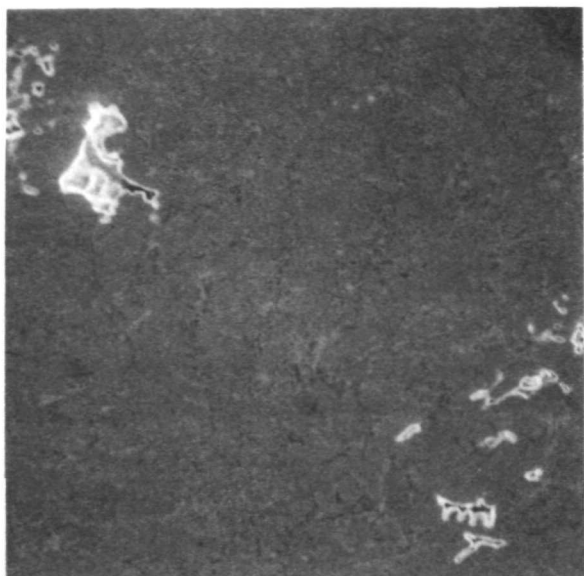
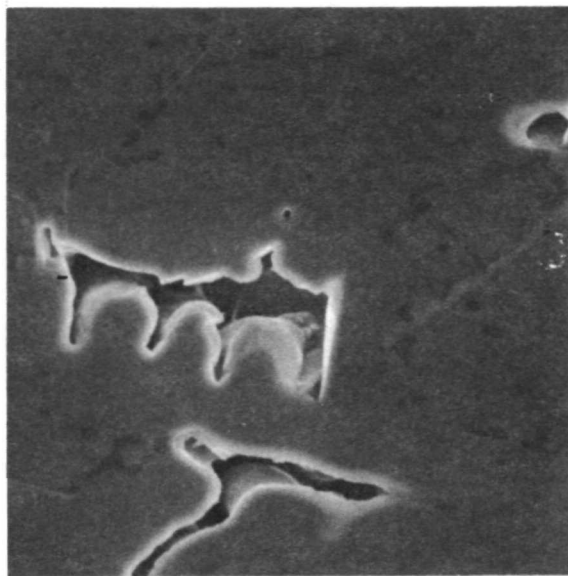
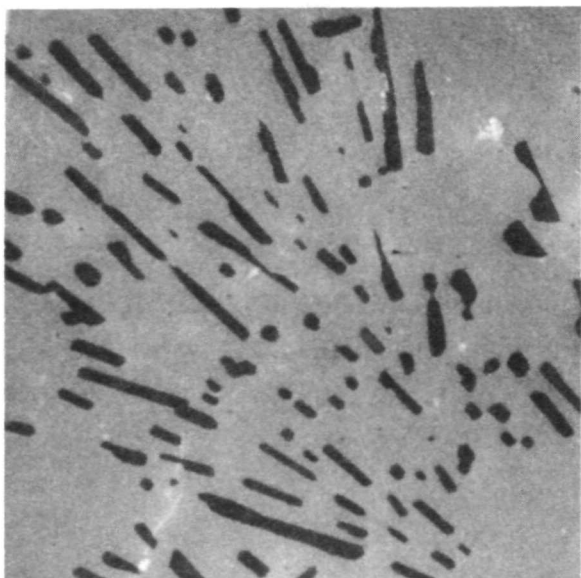
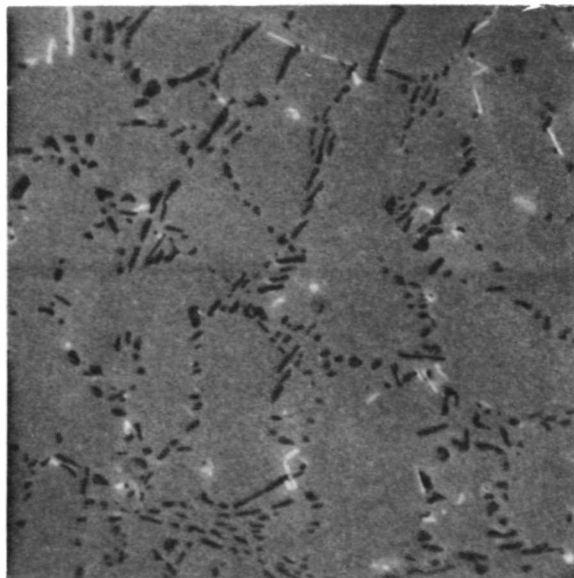
Figure 6

Four Views of Fracture Features in the Miniature Impact Sample  
Made from a Piece of the Specimen in Figure 1.

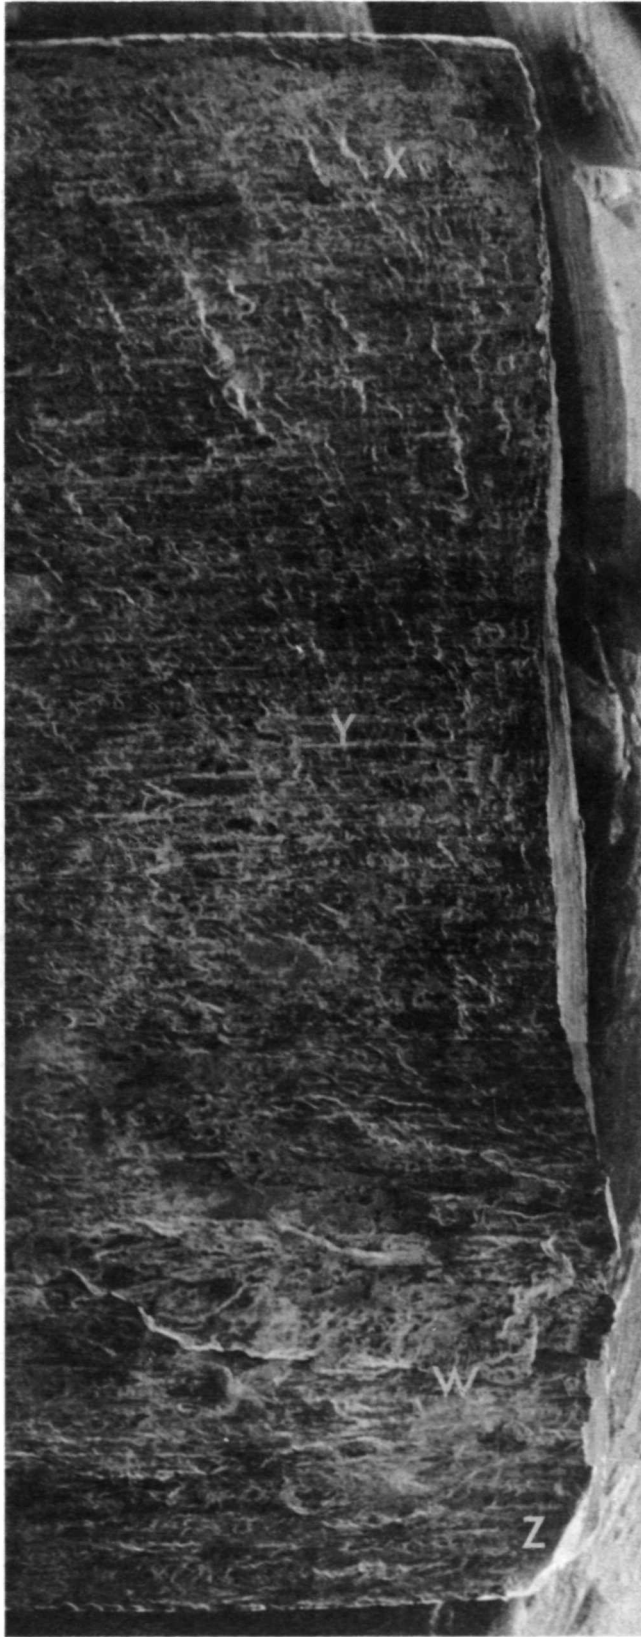
Figure 3 presents a low-magnification montage of three SEM photographs. The hole edge is on the right. This figure suggests that the fatigue crack originated from the region at the bottom right edge. Various areas were magnified (Fig. 4), fatigue striations could be readily identified, and their orientation pointed to the region at the bottom right edge of Fig. 3 as the initiation point.

Attempts to examine the details of the edge at the hole (i.e., perpendicular to the arrow in Fig. 3) were unsuccessful, because the hole had many machining marks (presumably produced during cutting of the specimen to open the crack or later). Hence, the precise initiation point could not be located.

Composite SEM Photographs of Edge A (of Fig. 1)  
Suggesting Initiation from the Lower Right Edge.

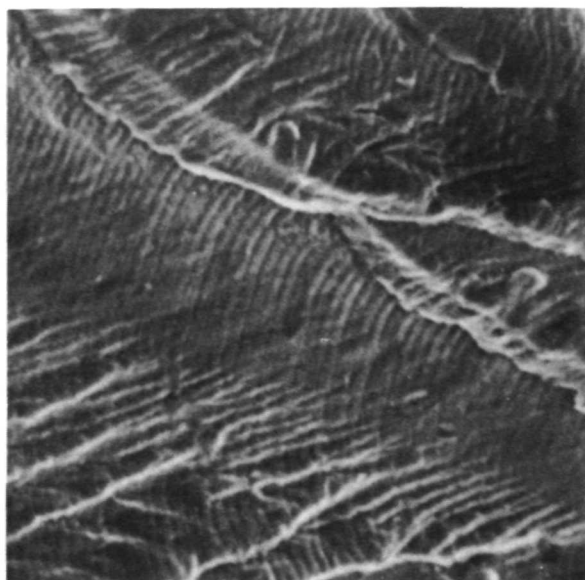
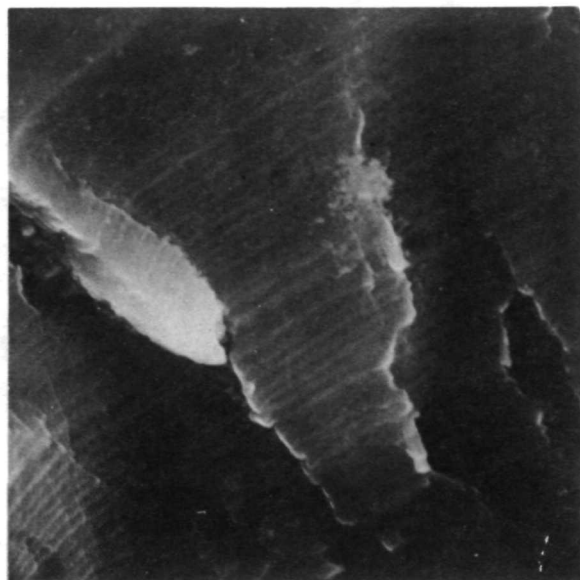
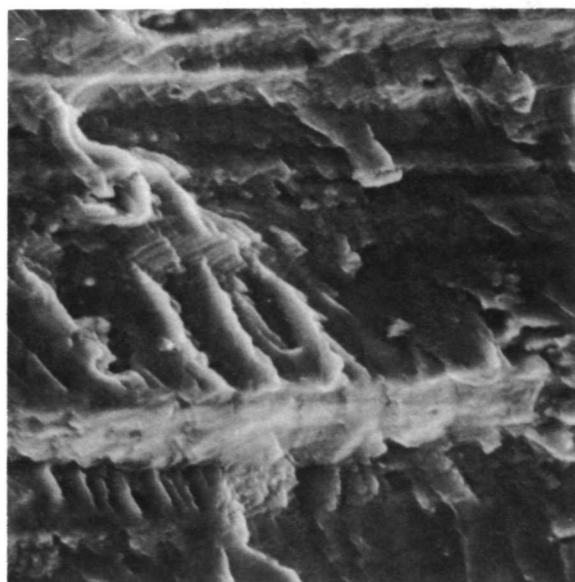
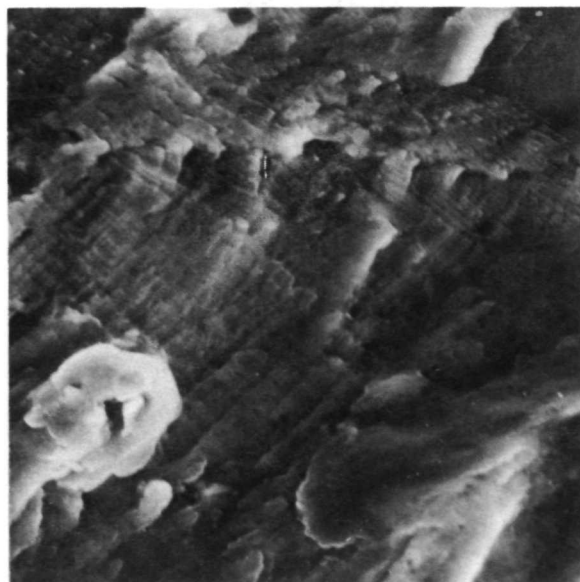
Figure 4

(a) Area W, (b) Area X, (c) Area Y, and (d) Area Z of Fig. 3 at High Magnification.

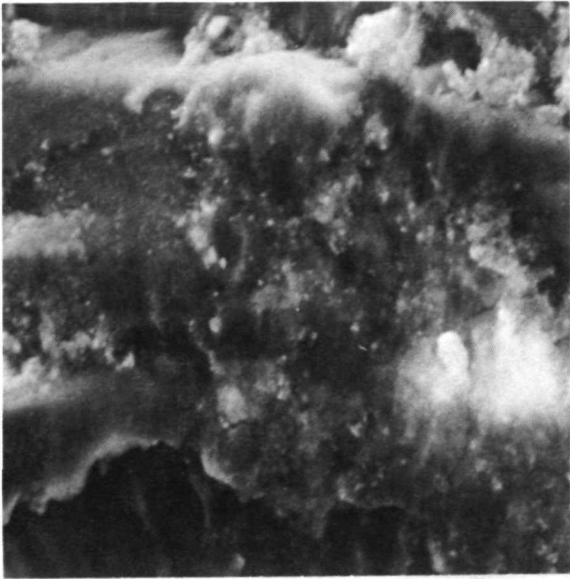
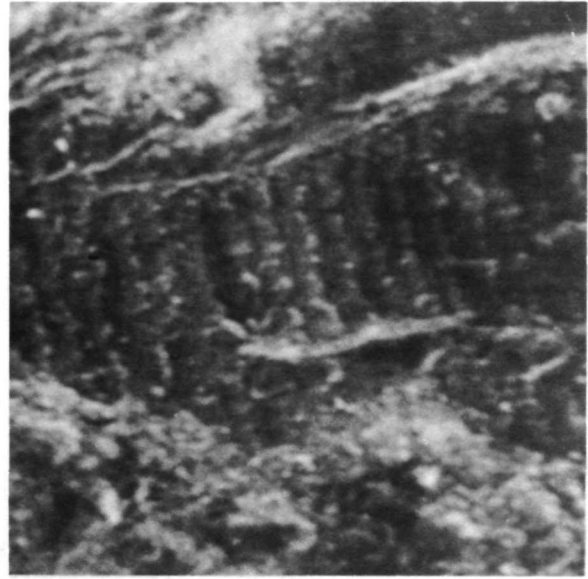
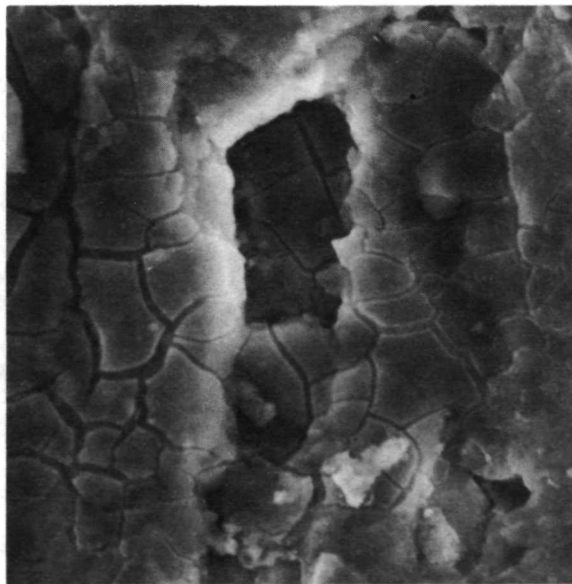
Figure 5

In addition to striations, many areas where the fatigue features were either absent or masked were also observed (Fig. 5). Nondispersive X-ray examination of some of the corroded areas indicated the presence of Al, Zn, and Cu, all three elements present in 7075 alloy (Fig. 6a). By comparison with spectra from a mixture of equal amounts of NaCl and Na<sub>2</sub>SO<sub>4</sub> (Fig. 6b) the presence of chlorine and sulfur is also confirmed in the spectra (Fig. 6a) from the corroded area. Frequently very small peaks of elements identified as silver and cadmium were observed in various areas; no source for these can be suggested.

Finally, the corrosive environment attacked certain areas, masking or obliterating fatigue features at these locations. Since many more clean areas exhibiting fatigue features could be observed over the whole crack surface, it is concluded that the role of corrosion in initiating and propagating this crack was very small, if any. The results suggest that the crack would have also originated or propagated in the absence of the corrosive environment.

Corrosion Debris at Various Locations  
on the Fracture Face in Fig. 2.

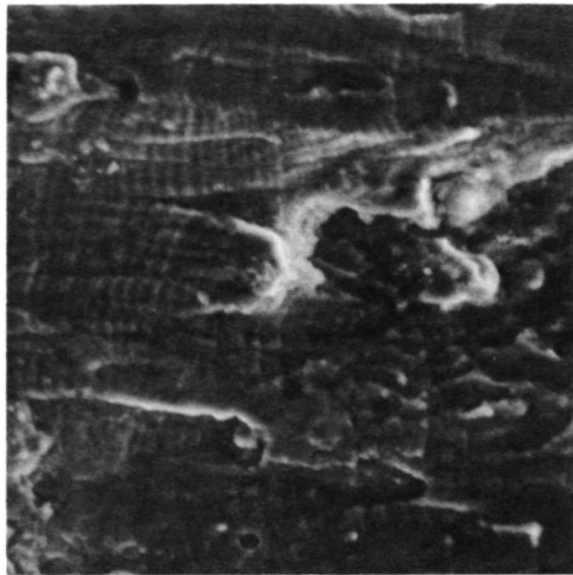
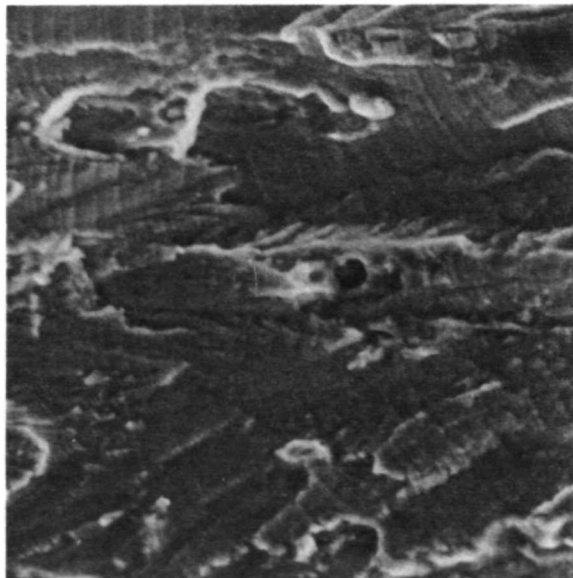
Figure 7

The observed crack was definitely due to fatigue--fatigue striations were readily visible over the total crack surface (e.g., Fig. 7 is nearly three-fourths the way from the initiation region to overload region) except at the end where overload features were observed. These were presumably caused by the opening up of the crack from the other end (away from the hole). The exact cause of the fatigue origin cannot be determined. Stress corrosion initiation at the edge is ruled out because the crack originated at or very close to the edge and no stress corrosion features were recognizable. The most probable cause seems to be a machining notch at the initiation point in the hole, although initiation at a possible inclusion is not completely excluded by our observations. However, no inclusion, or cavity from which an inclusion may have dropped out, was observed at or near the suspected initiation point. Indeed, the fact that inclusions were very hard to find on most of the fatigue surface suggests that this region came from relatively clean alloy.

Fatigue Features at About  $\frac{3}{4}$  the  
Distance from the Initiation Edge  
to the End of the Fatigue Crack.

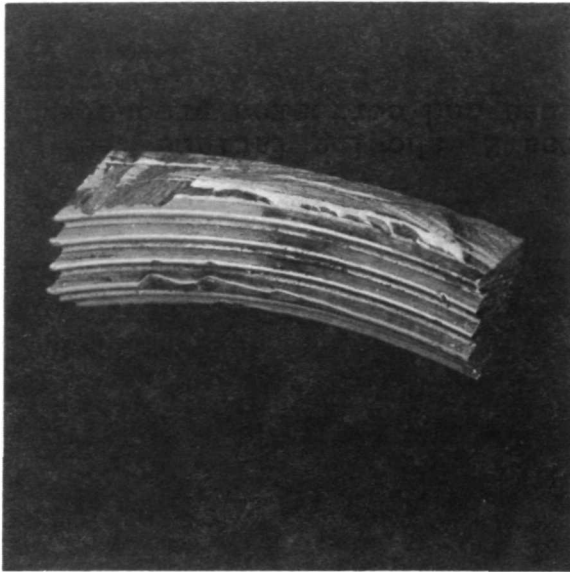
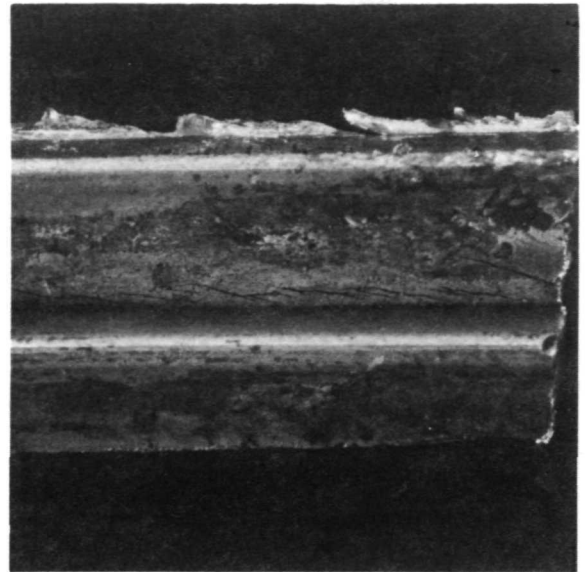
Figure 1

The initiation of cracks at various points along the root may result from the presence of machining notches or from pits and spalls caused by corrosion. Due to their narrower cross section, the roots already have a higher stress concentration, which may accelerate corrosive processes. Stress-corrosion effects may also be operative in crack initiation, particularly where certain areas fell out of the thread root due to preferential attack at grain boundaries and thus further enhanced the stress concentration effects.

Specimen as received by IITRI

Details of a thread root from Fig. 1a.

Optical Photomacrographs of Failure in Propeller Hub.
